BUREAU OF METEOROLOGY
DEPARTMENT OF THE ENVIRONMENT

SEVERE WEATHER AND FLOODING

NORTH QUEENSLAND

JANUARY 1998

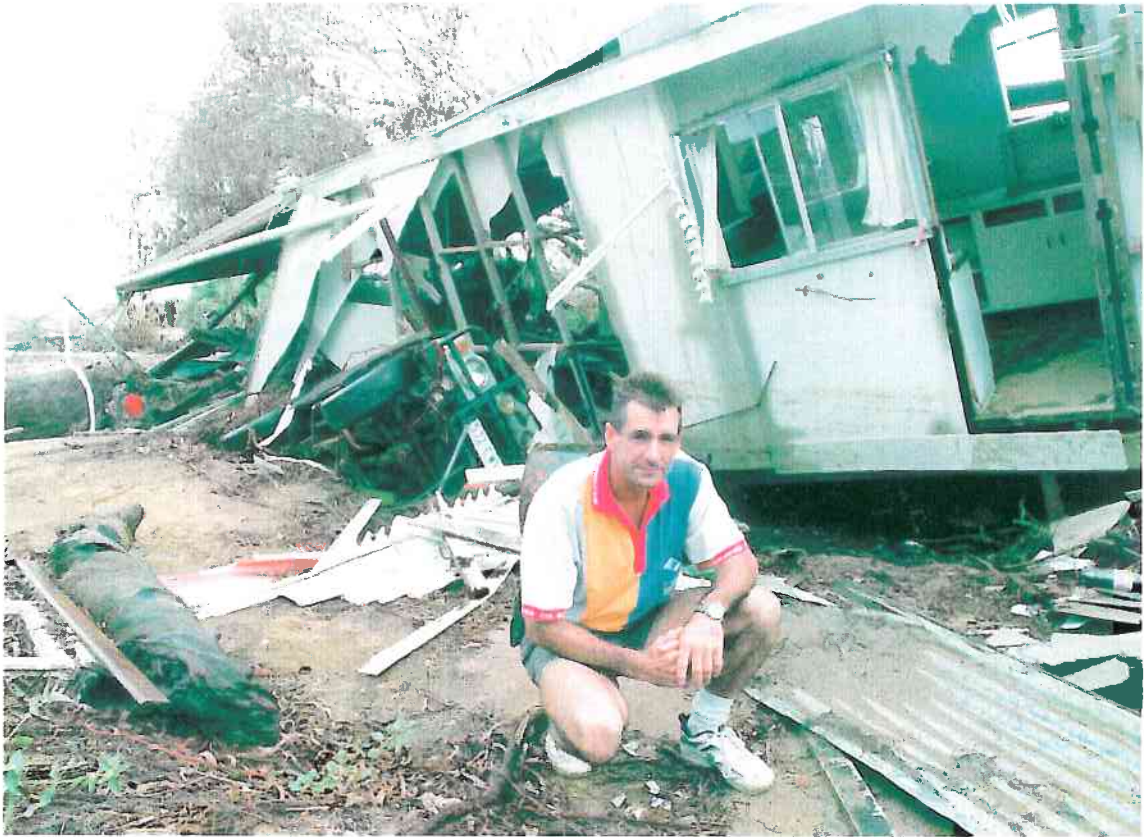
**Severe flood damage at Black River, north of Townsville.
(Photo courtesy of Queensland Newspapers)**

The small communities of Black River and Bluewater, just north of Townsville, suffered extensive damage. At Black River, it was estimated that flood water impacted on 48 houses with the majority being rendered uninhabitable. Fourteen(14) were totally destroyed with eight being washed away. A total of 40 residences were severely impacted at Bluewater with most being uninhabitable for some time.

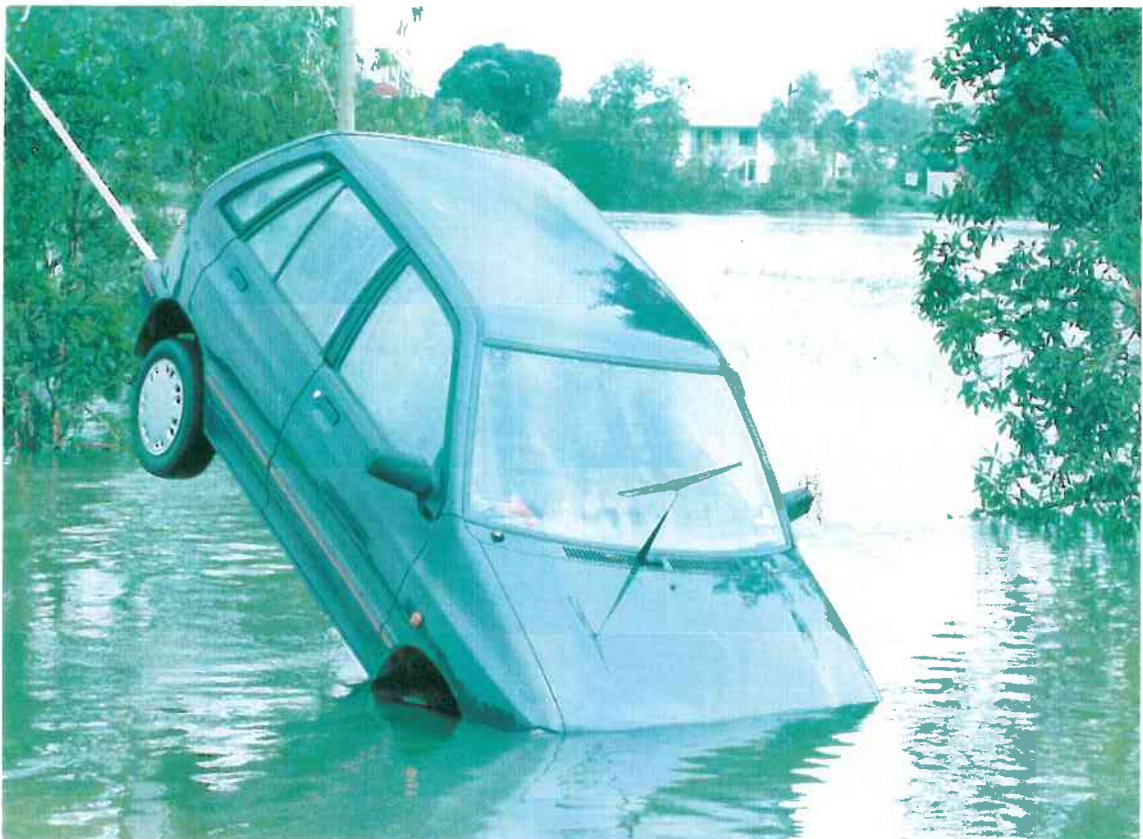
**Car swept away by floodwaters, Townsville.
(Photo courtesy of Queensland Newspapers)**

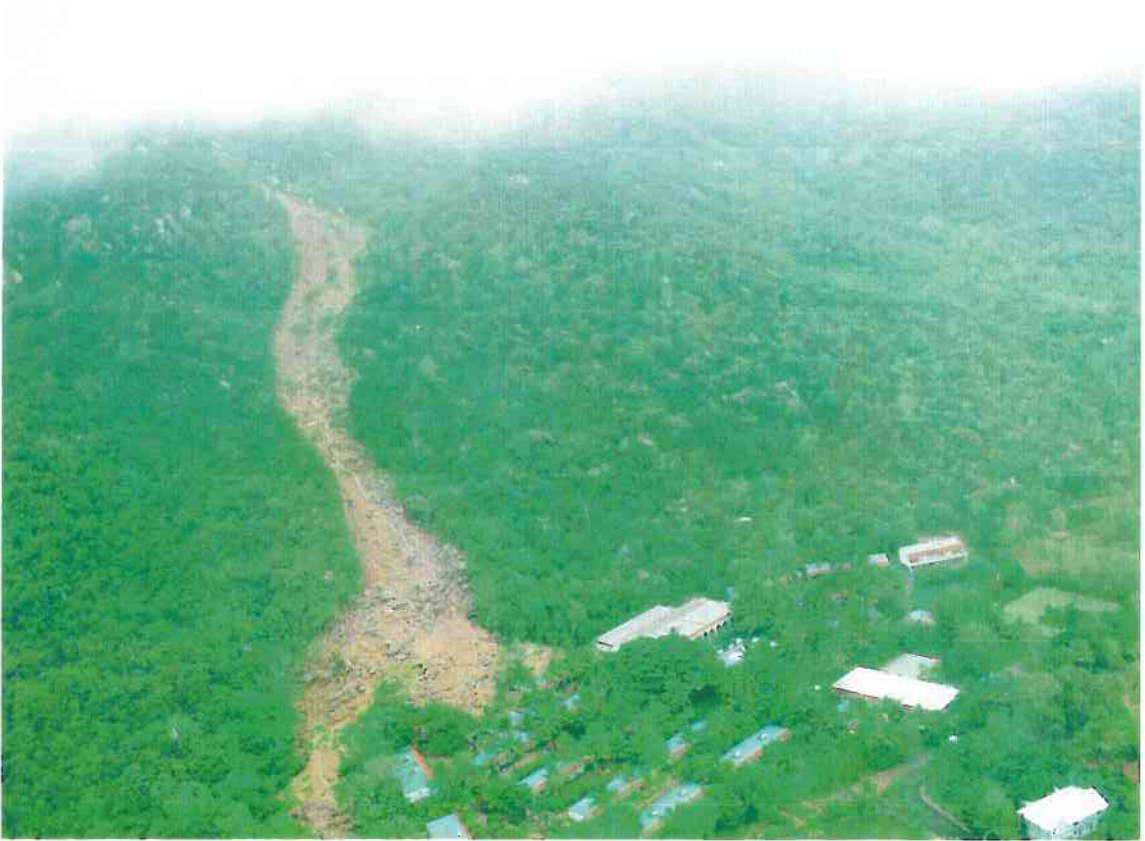
**Landslide at Magnetic Island.
(Photo courtesy of Queensland Newspapers)**

On Magnetic Island, a huge land slide, estimated to be three times the size of the Thredbo disaster, caused major damage to a resort complex.

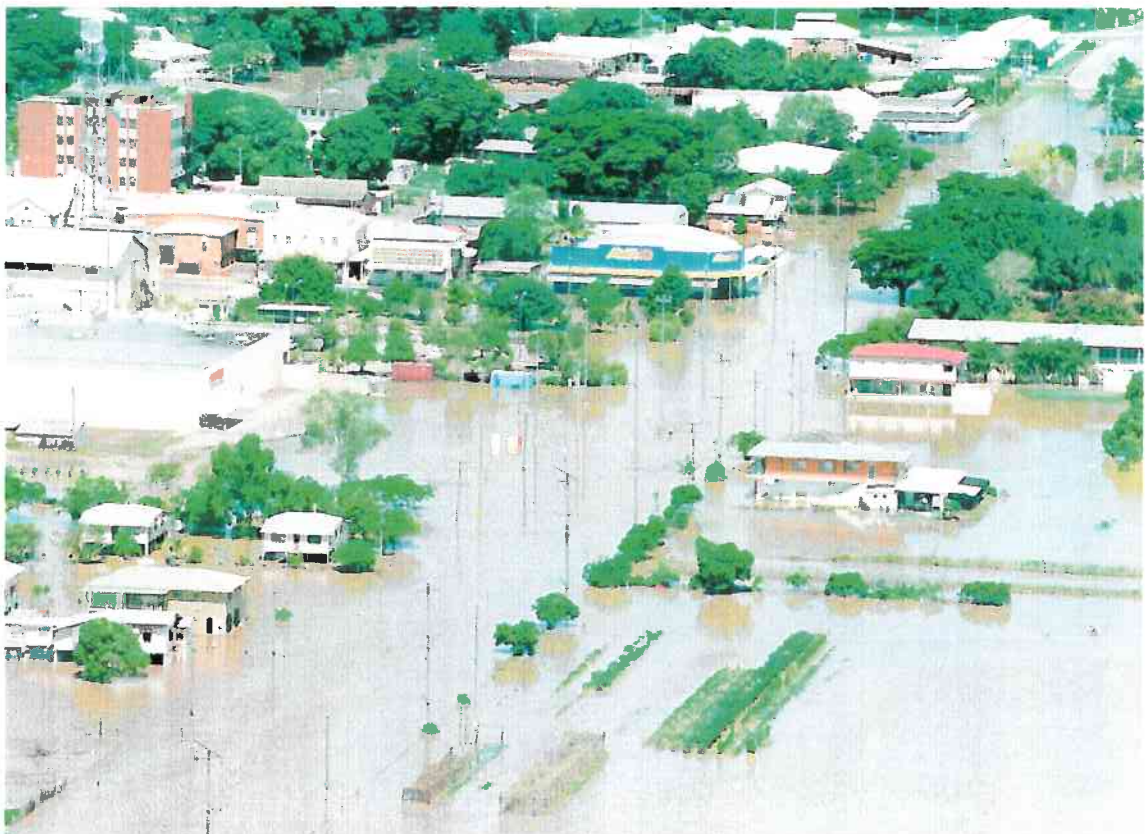
**Major flooding through the township of Ingham.
(Photo courtesy of Queensland Newspapers)**

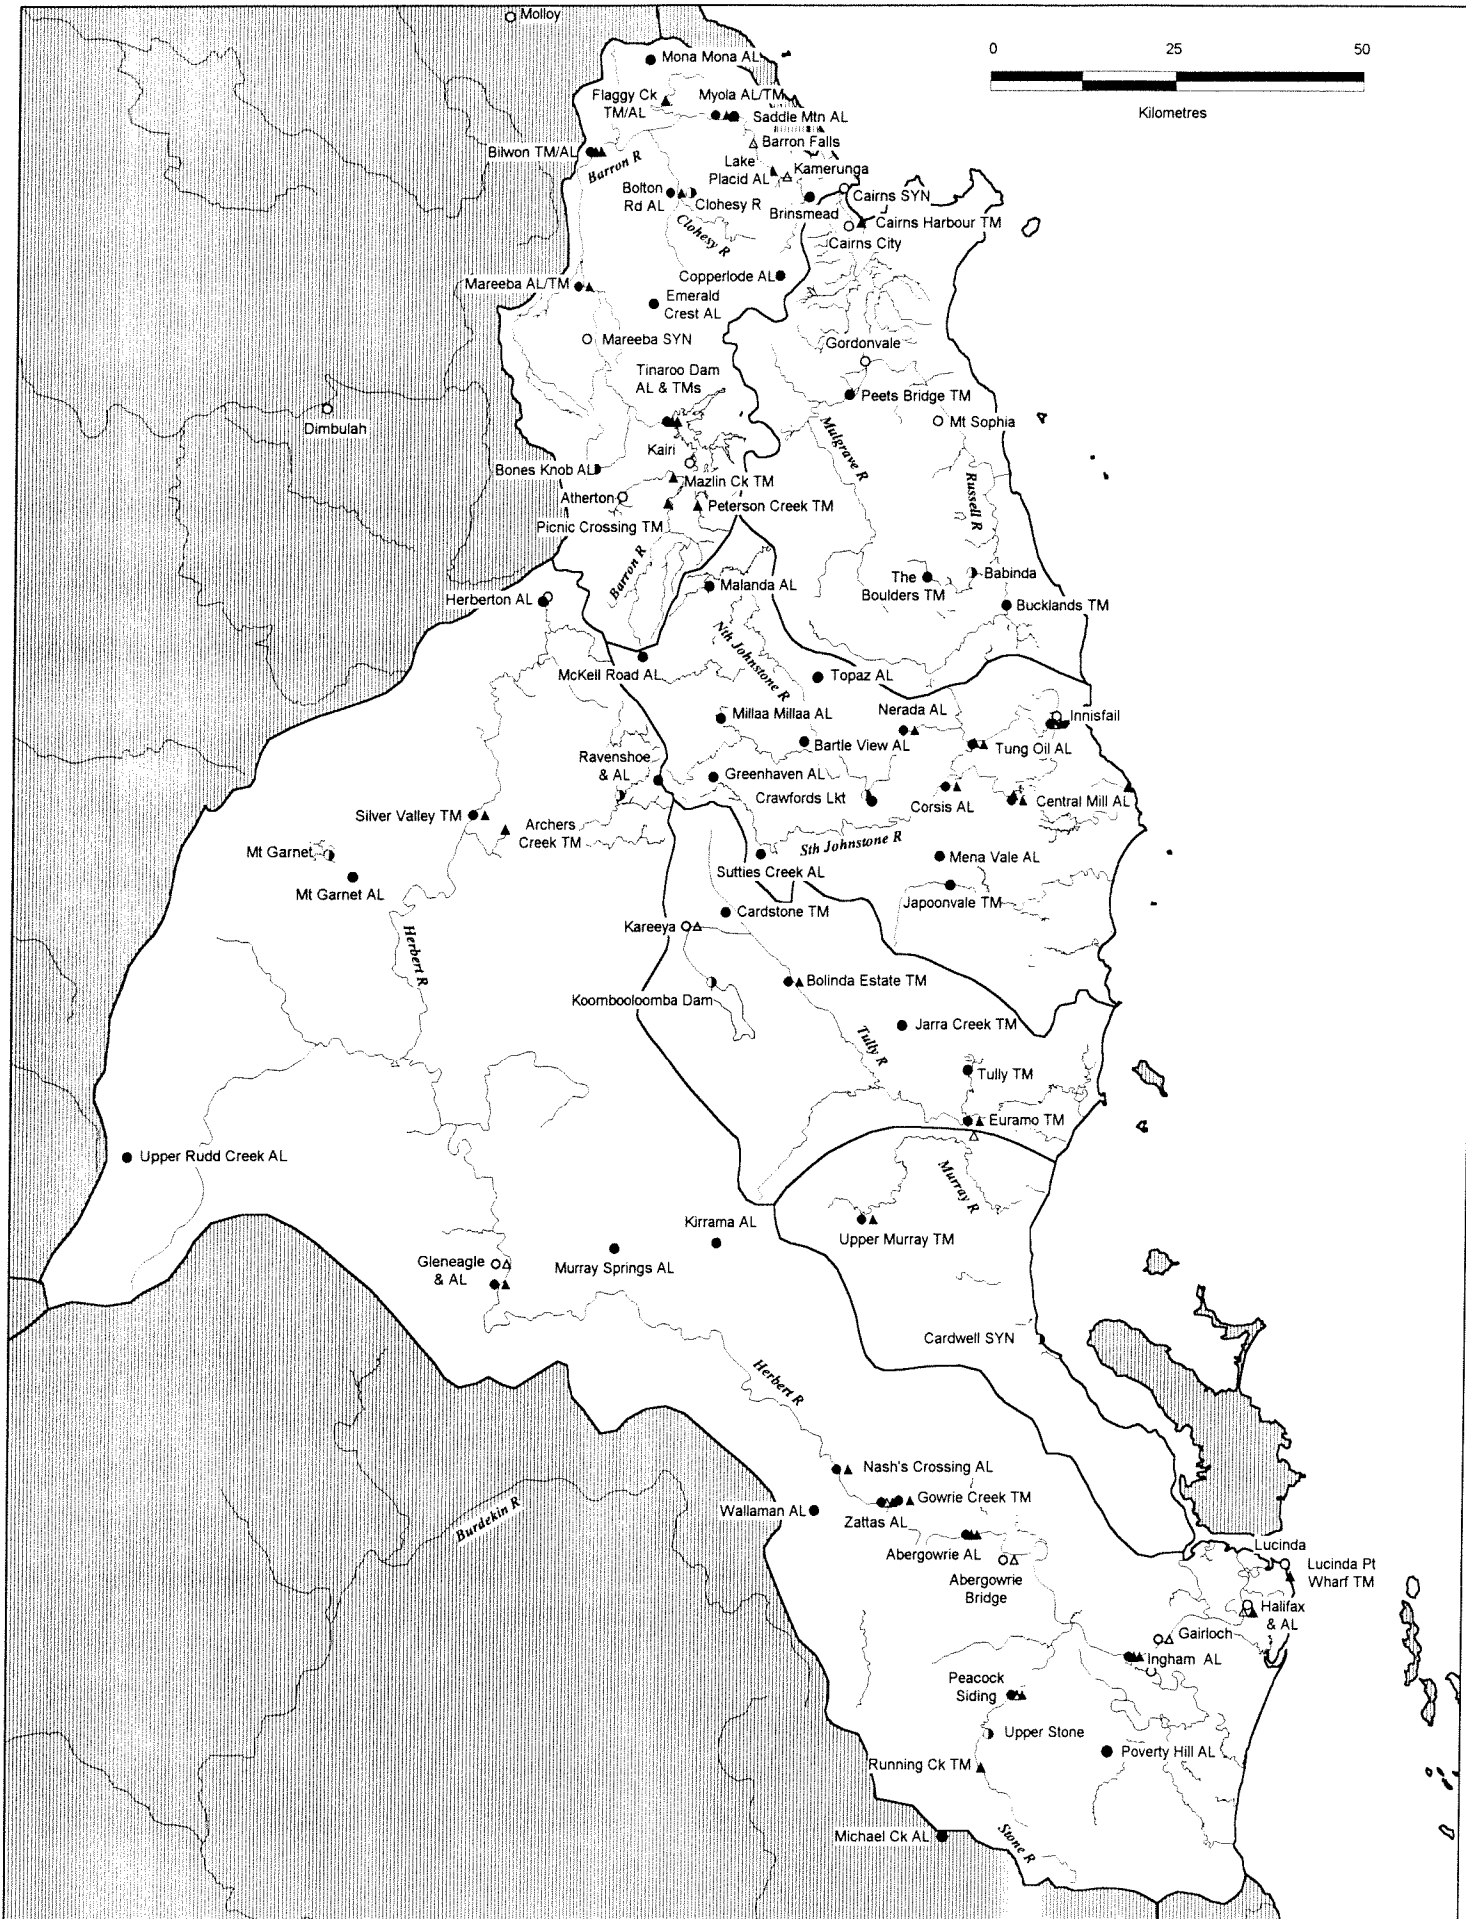
Figure 1.2

**HERBERT, TULLY, JOHNSTONE
& BARRON RIVERS
FLOOD WARNING NETWORK**

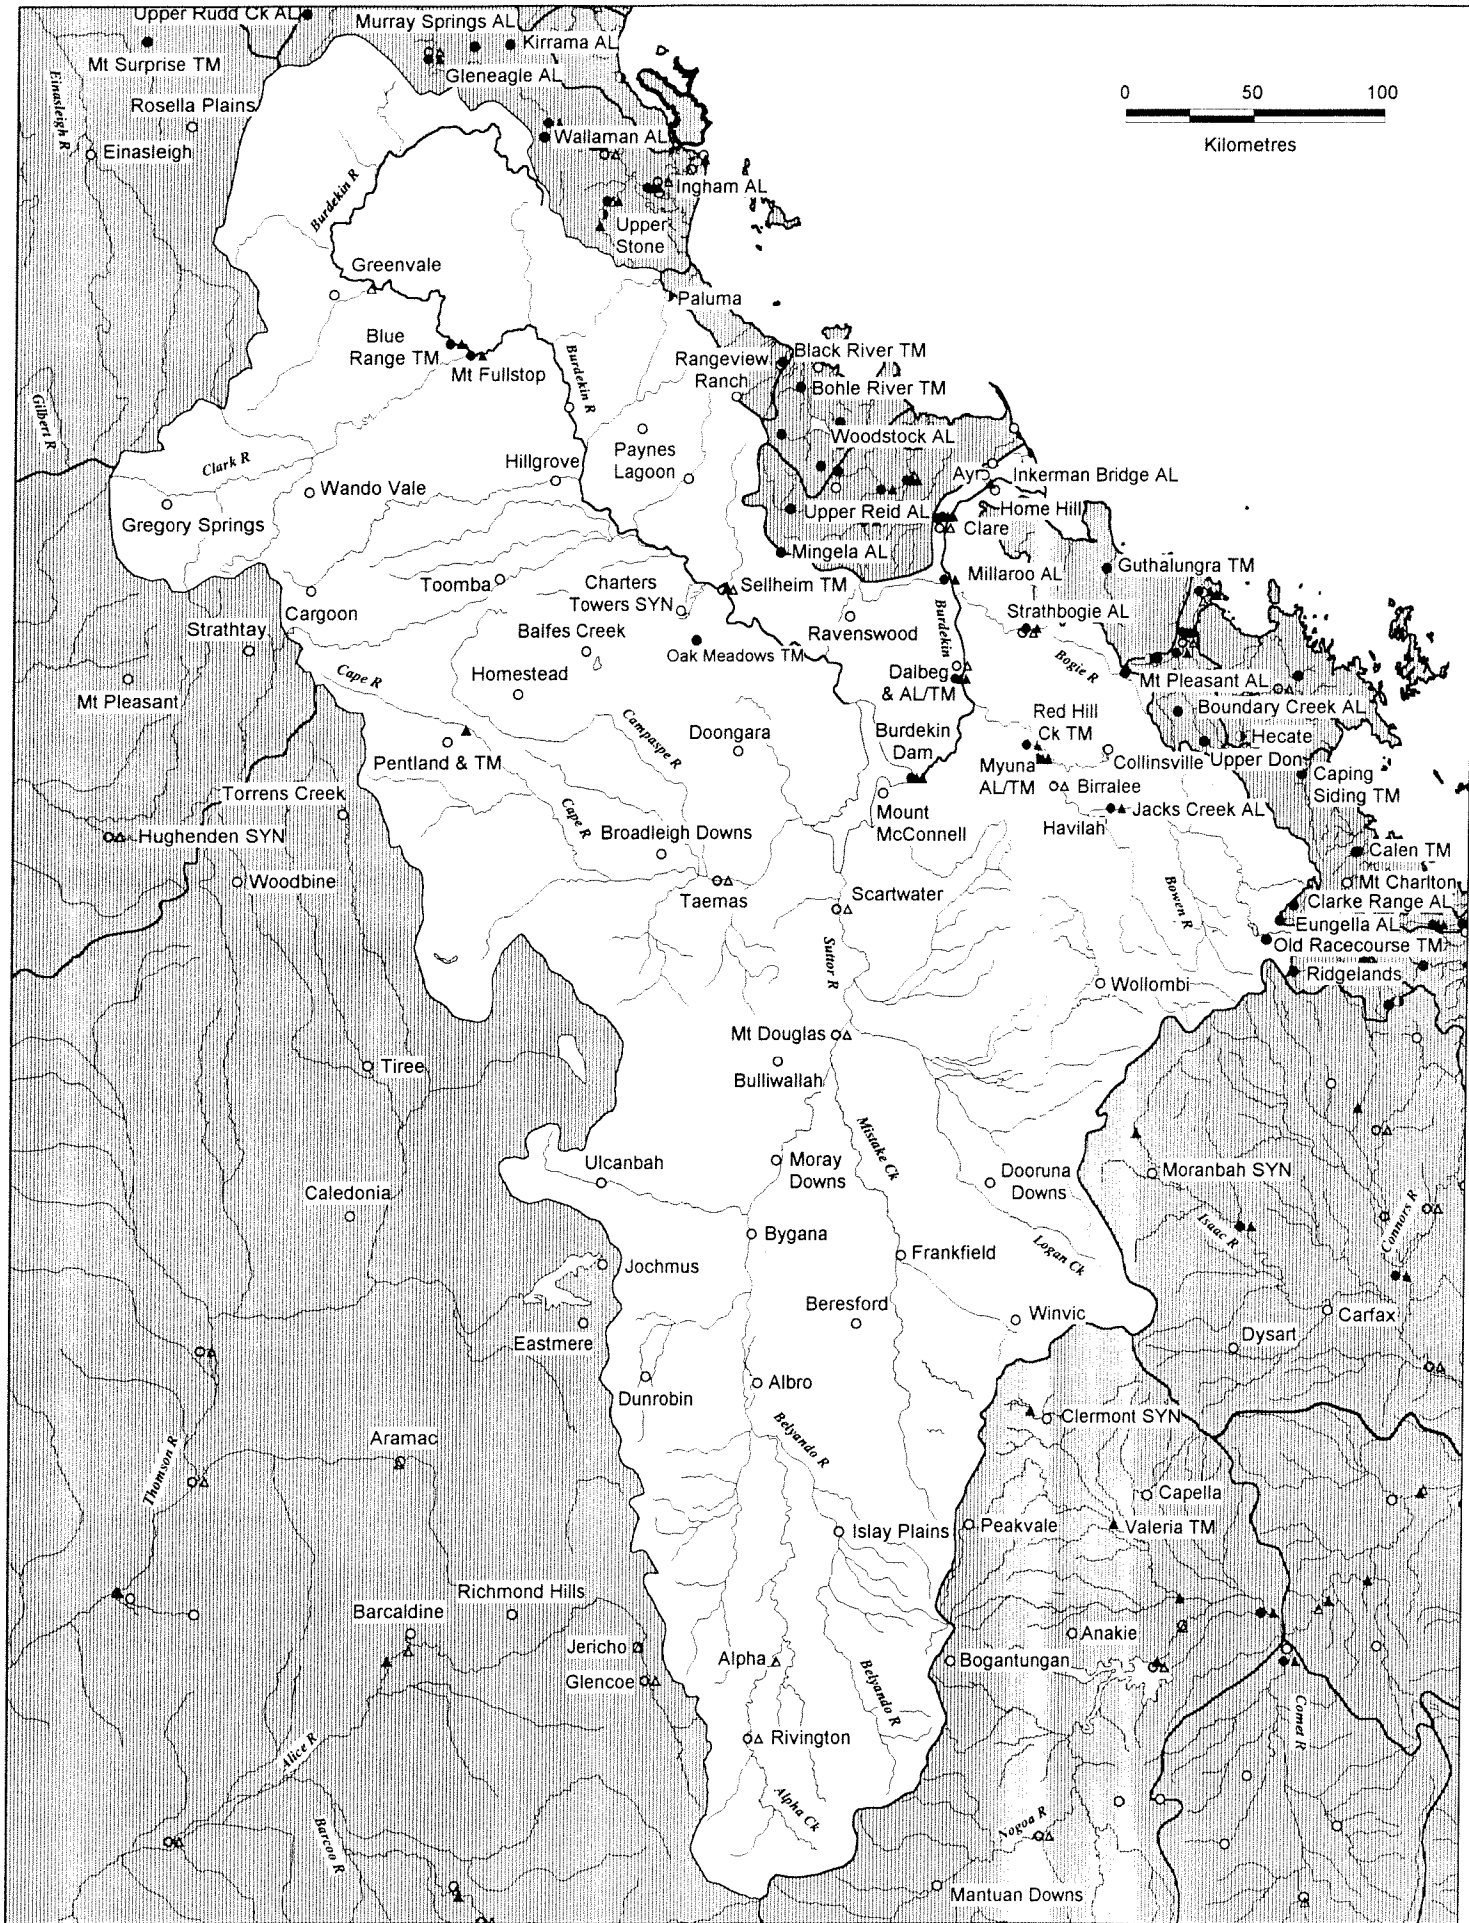
Figure 1.4

**BURDEKIN RIVER
 FLOOD WARNING NETWORK**

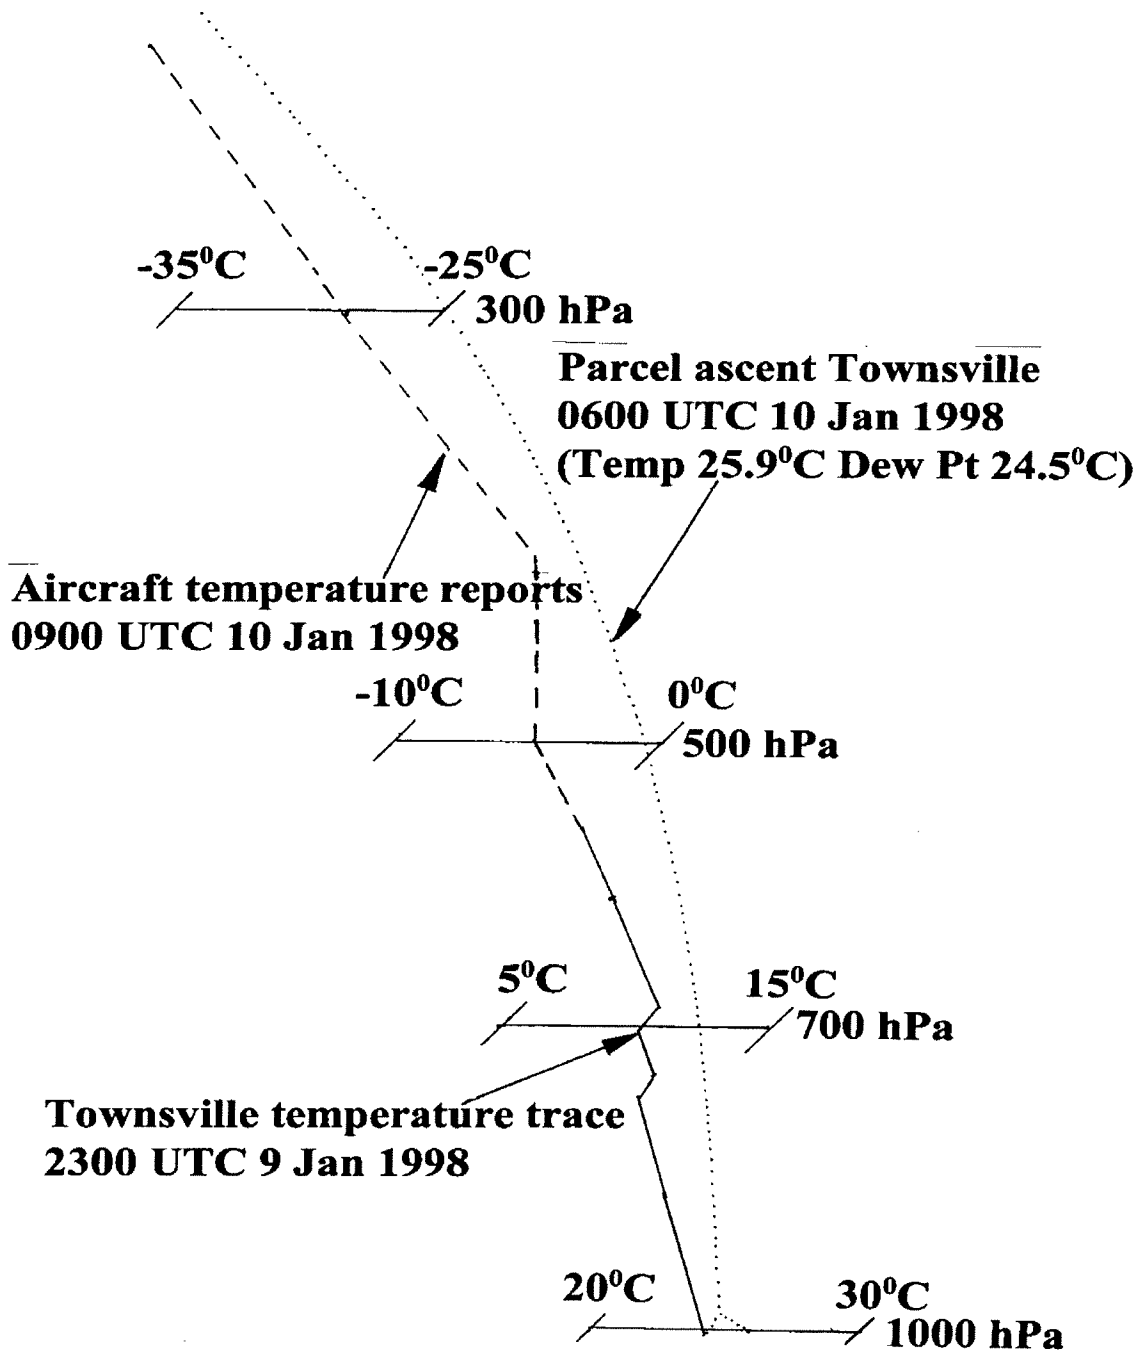
Figure 2.6 Upper Temperature Profile at Townsville
Dotted line is a moist adiabat which marks the saturated adiabatic lapse rate.

The 9am meteorological balloon flight at Townsville on 10 January 1998 only recorded temperature readings up to 550 hPa after which heavy rain on the payload formed into ice and prevented further ascent. The vertical temperature profile at Townsville that morning is plotted in Figure 2.6. This temperature trace is extended to higher levels from aircraft reports received in the Townsville area around 7 pm 10 January 1998.

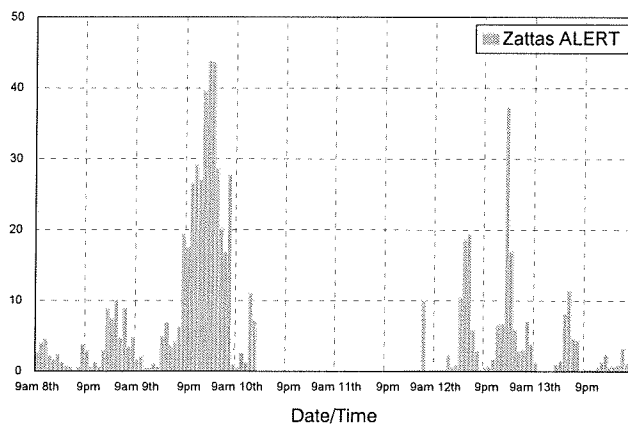
Figure 3.2(b) Temporal Pattern - Zattas

Until 8pm on 9 January rainfall rates at Zattas were quite low, typically below 10 mm/hr. However, from about 8pm 9 January, the heavy rainfall commenced abruptly and for a period of about 12 hours, rainfall intensities were at or above 20mm/hr. The heaviest rainfall occurred in two hours early on 10 January when rates of 40mm/hr were exceeded for two hours. At about 10am Saturday, the heavy rainfall eased quickly. Further periods of intense rainfall were recorded at Zattas on Monday 12 and Tuesday 13 January but, despite being heavy, only lasted one or two hours.

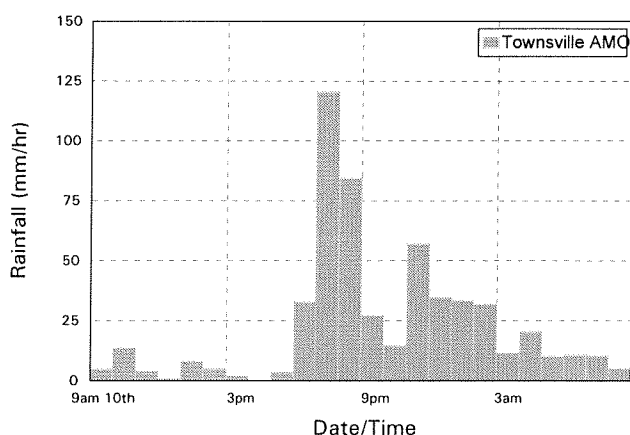
Figure 3.2(c) Temporal Pattern - Townsville

As indicated in Figure 3.2(c), the heavier rainfall commenced at Townsville AMO at about 6pm on Saturday 10 January and continued until about 3am. During this period, rainfall rates over

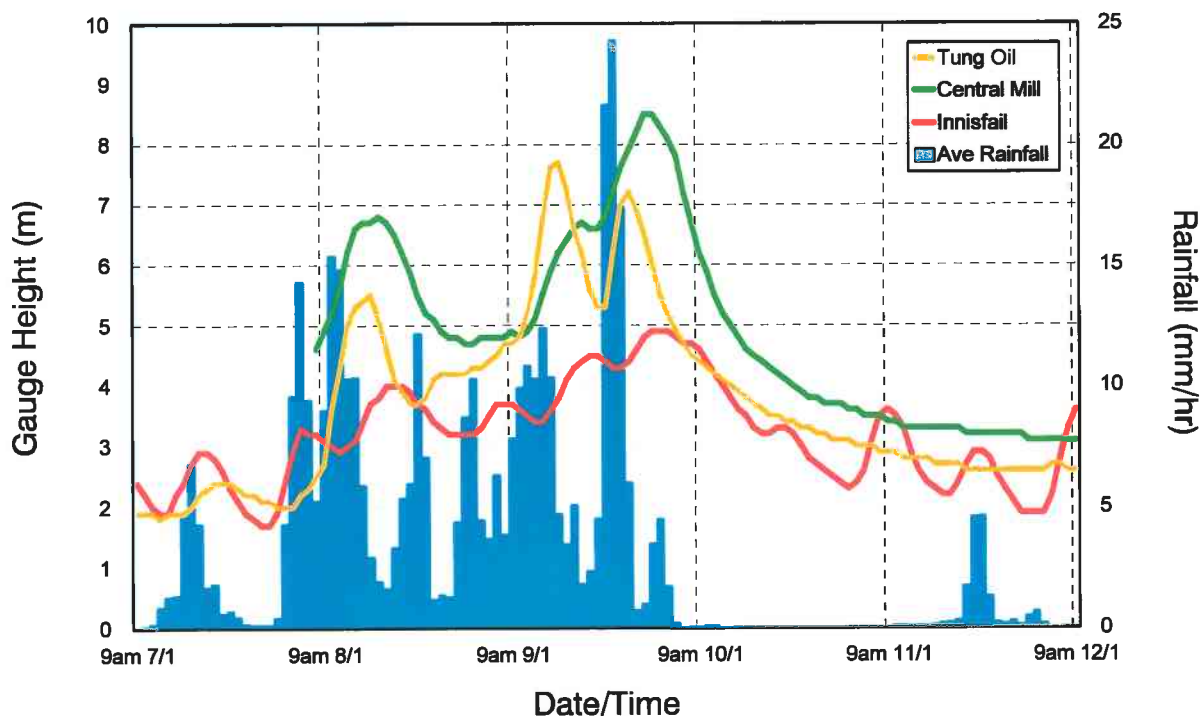
Figure 4.1 Johnstone River

With the onset of the heavy rainfall burst on 8 January, river levels upstream of Innisfail started to rise rapidly, responding to the intense rainfall bursts. Several peaks were recorded at the gauging stations, with an initial peak occurring at 3pm on 8 January followed by a second higher peak overnight on 9/10 January. The North Johnstone River reached 7.2 m at Tung Oil at 12am on 9 January, just above the minor flood level, and 8.6 m at Central Mill on the South Johnstone River at 3am on the next morning. The flood level at Central Mill was 0.6 m above moderate flood level. At Innisfail the river reached

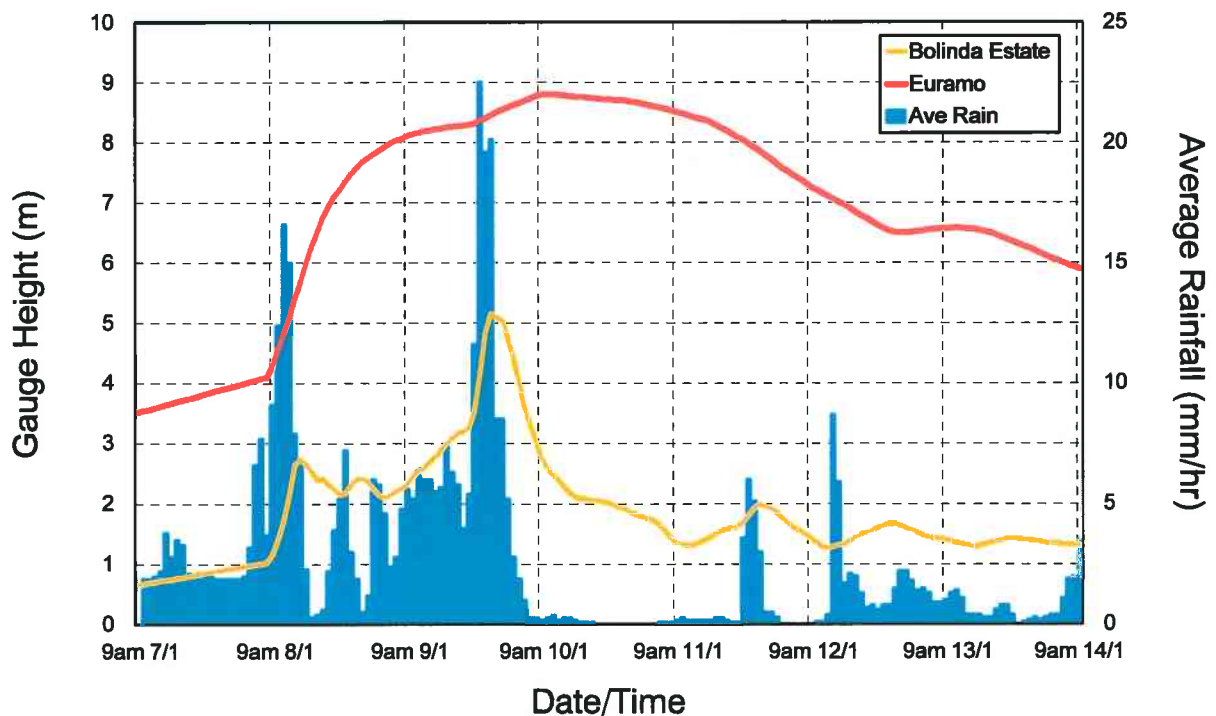
Figure 4.2 Tully River

At Euramo, the Tully River began to rise slowly on Wednesday 7 January. The rate of rise increased on Thursday 8 with the onset of heavy rainfall and was nearing a peak of about 8.3 metres on the evening of Friday 9. However, the heavy rainfall on that evening caused renewed rises in the Tully River and a peak of 8.8 metres, about 0.7 metres above the highway, was reached at Euramo on the morning of Saturday 10 causing moderate flooding. The river receded and was approaching minor flood levels when the renewed rainfall of the Sunday 11 and Monday 12 caused another short rise. The river eventually fell below minor flood level on the morning of the Wednesday 14.

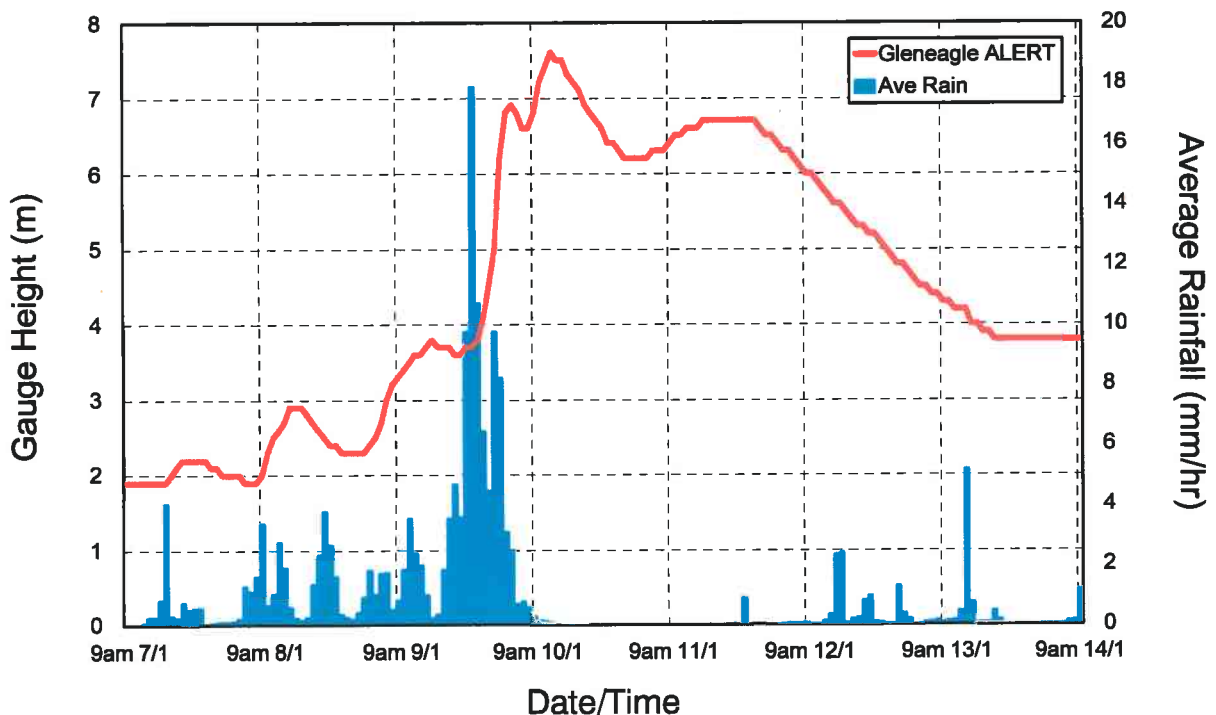
Figure 4.3 Upper Herbert River

While there was a significant rise at Gleneagle, the peak occurred at noon on Saturday 10 January from local heavy rainfall with a later lower peak on Sunday evening 11 January. Neither peak had any impact on the major flood peak at Gairloch but did cause relatively high levels in the lower catchment to be maintained longer than normal.

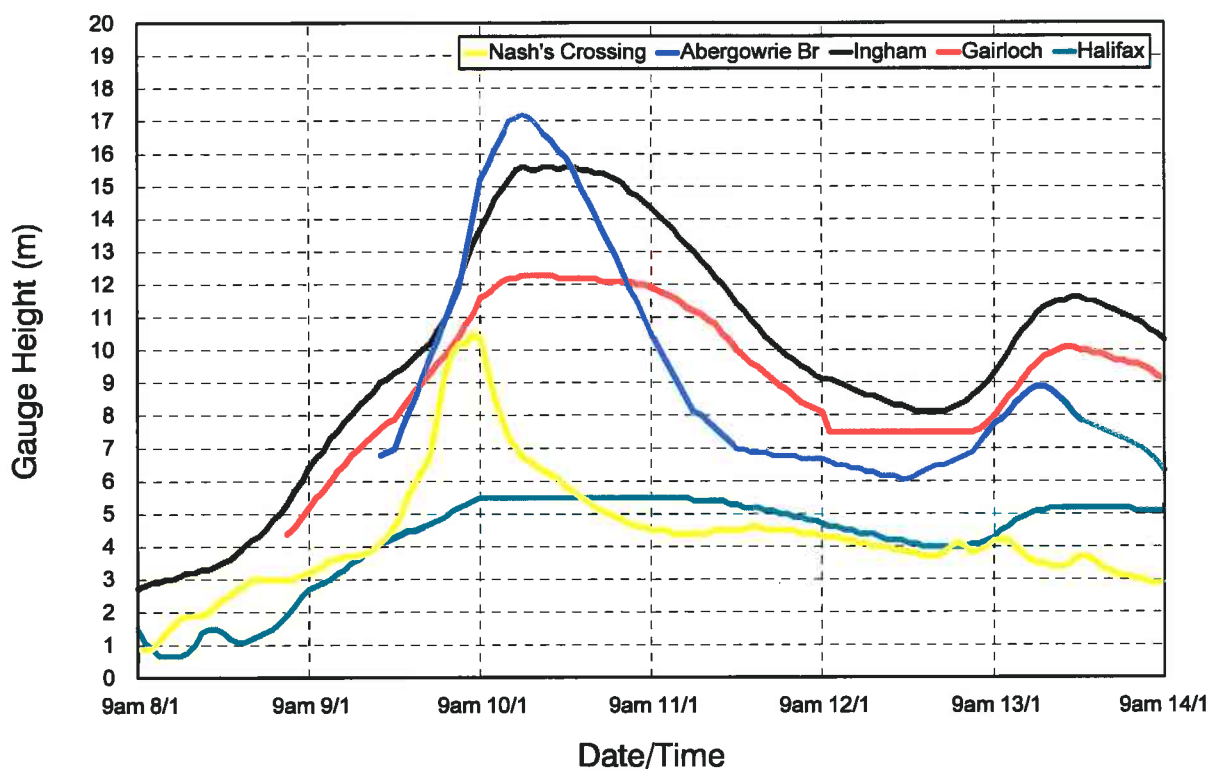
Figure 4.5 Lower Herbert River Levels

The rain on Monday and Tuesday caused renewed rises at Gairloch, shown in Figure 4.5, and resulted in a 1.0 to 1.3 metres rise at Halifax.

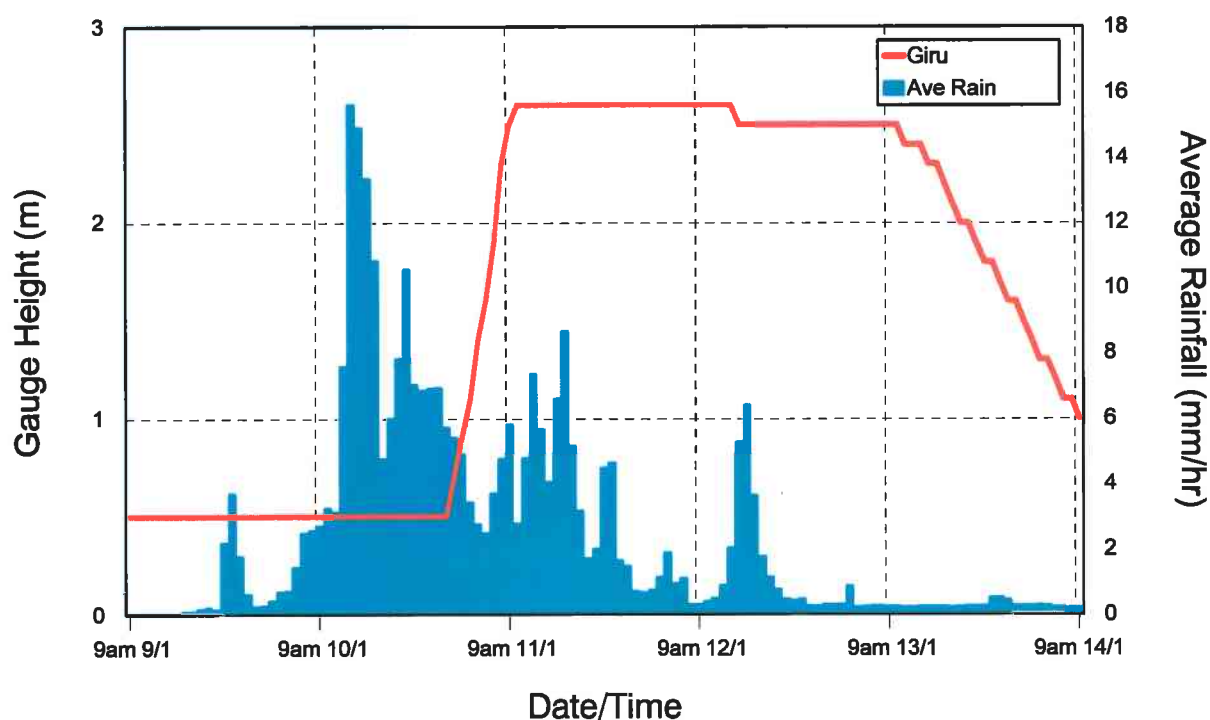
Figure 4.6 Haughton River

The concentration of the rainfall in the north of the catchment was reflected in the rise of river levels in the Haughton River catchment being first recorded at Powerline due to the significant inflow from Major Creek. River levels started to rise at 5am on 10 January in response to the initial rainfall and then started to rise rapidly later in the day around 6pm following the heavy rainfall. Levels rose to an initial peak of 8.91 m by 11.30am on Sunday 11, followed by a second peak of 9.43 m early in the morning of Monday 12, as the flood flows arrived from the upper Haughton River catchment. The peak flood level of 9.43 metres was 1.43 m above the major flood level.

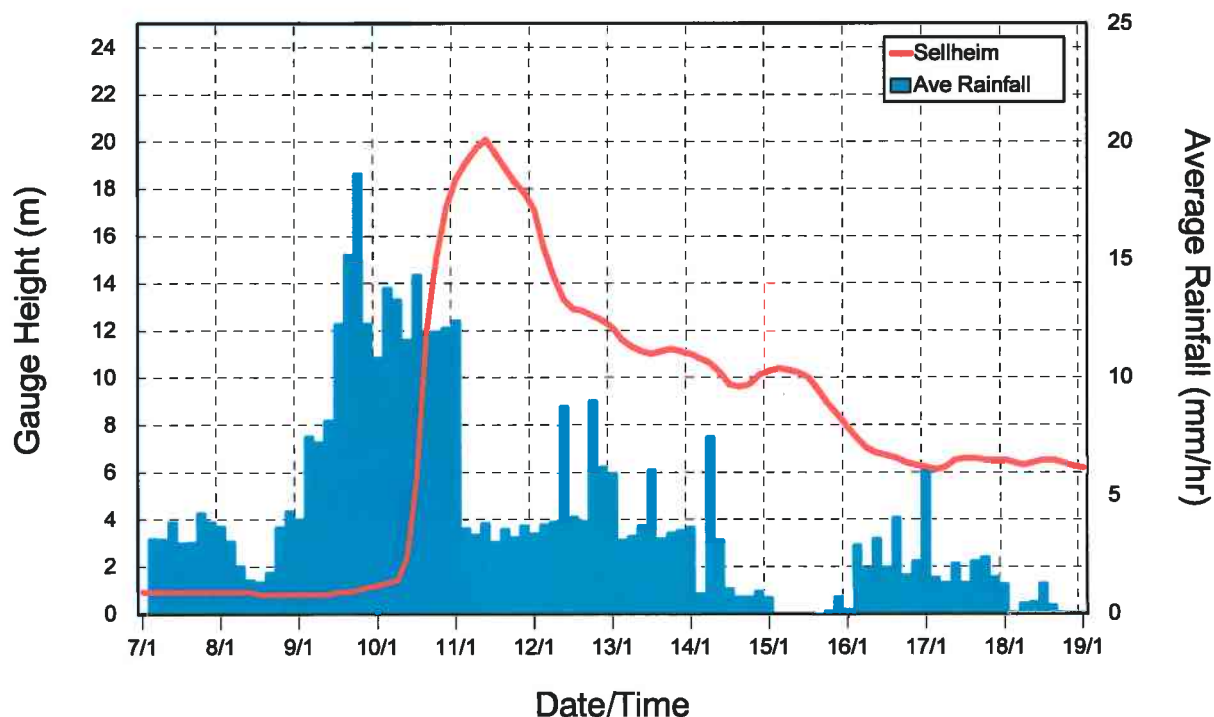
Figure 4.7 Upper Burdekin River

The heavy rainfall in the upper Burdekin catchment caused rapid rises in river levels, commencing at Mt Fullstop at 2.30am and at 5.30pm at Sellheim on Saturday 10 January. At Sellheim, river levels rose by nearly 20m in just over 24 hours, from 1.99m at 5.30pm

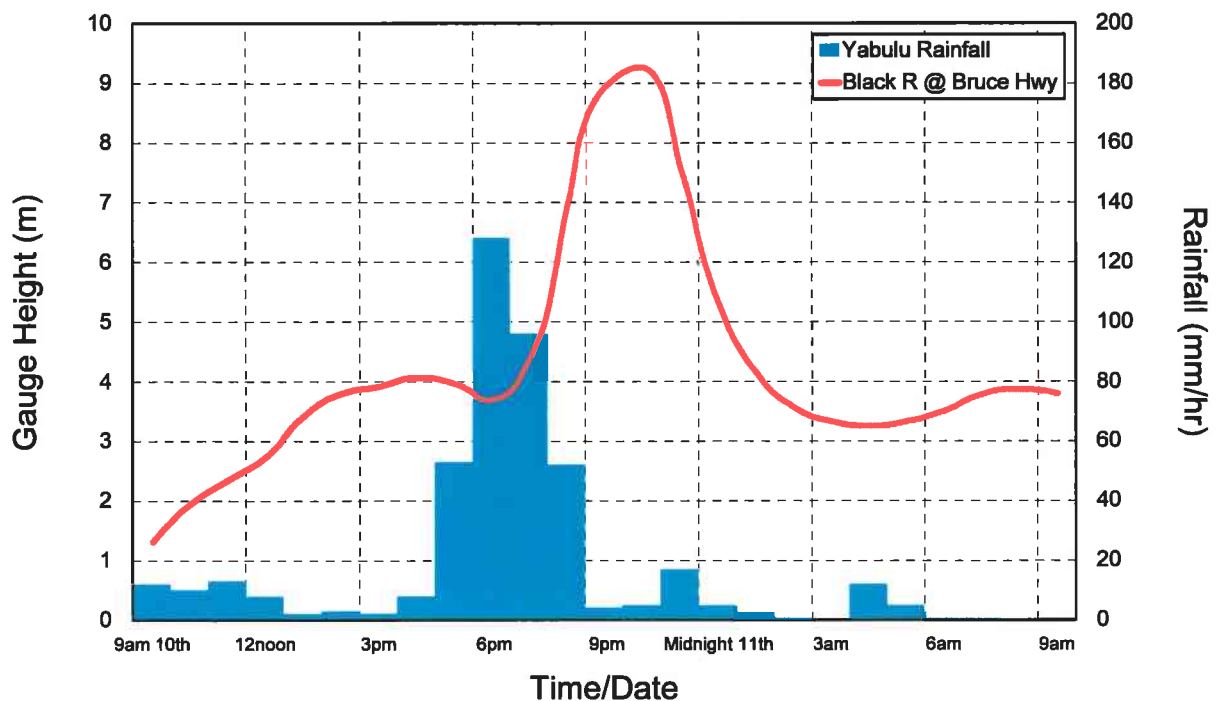
Figure 4.8 Black River

Figure 4.8 shows the relationship between the hourly rainfall recorded at Yabulu and the Black River hydrograph. It indicates that the time between the heavy rainfall between 6 and 7pm on 10 January and the flood peak at the Black River station is only about 2-3 hours.

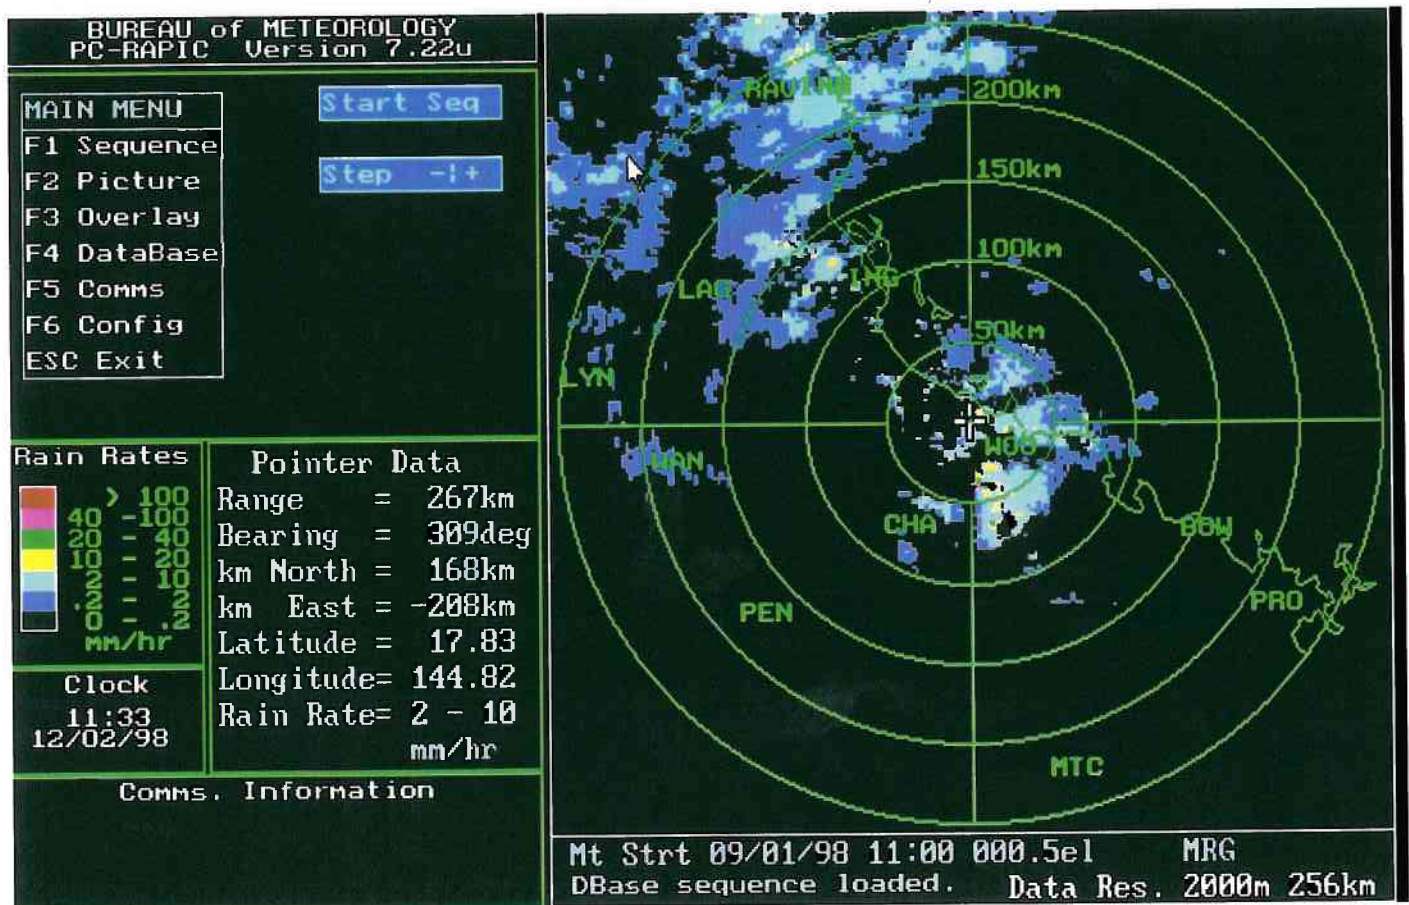
Figure 5.1(b) Mt Stuart Radar 9pm 9/1/98

Two particularly significant radar sequences are described below and are given in Figures 5.1 and 5.2. In these Figures, the radar echoes indicate areas of rainfall. An estimate of the intensity of rainfall (in millimetres per hour) is given by the colour, although this can only be used as a guide to the actual rain rates measured at the ground surface.

At 6pm 9 January 1998, weather radars, Figure 5.1(a), showed scattered areas of precipitation along the coast north of Ayr and an area overland west of Innisfail which marked the location of the tropical low (ex *Sid*). Around this time the monsoon trough was moving down the coast towards Cairns (refer to Figure 2.4). By 9pm the monsoon trough was just south of Cairns and the radar showed, Figure 5.1(b), a band of heavy rain generated by the trough crossing the coast around and to the north of Innisfail. This band of heavy rain then rapidly developed, Figures 5.1(c) and (d), and at 3am 10 January 1998 the northern edge of this rain band crossed the coast near Cardwell. The mean sea level analyses at this time (Figure 2.4) showed that this band of heavy rain was located just to the south of the monsoon trough.

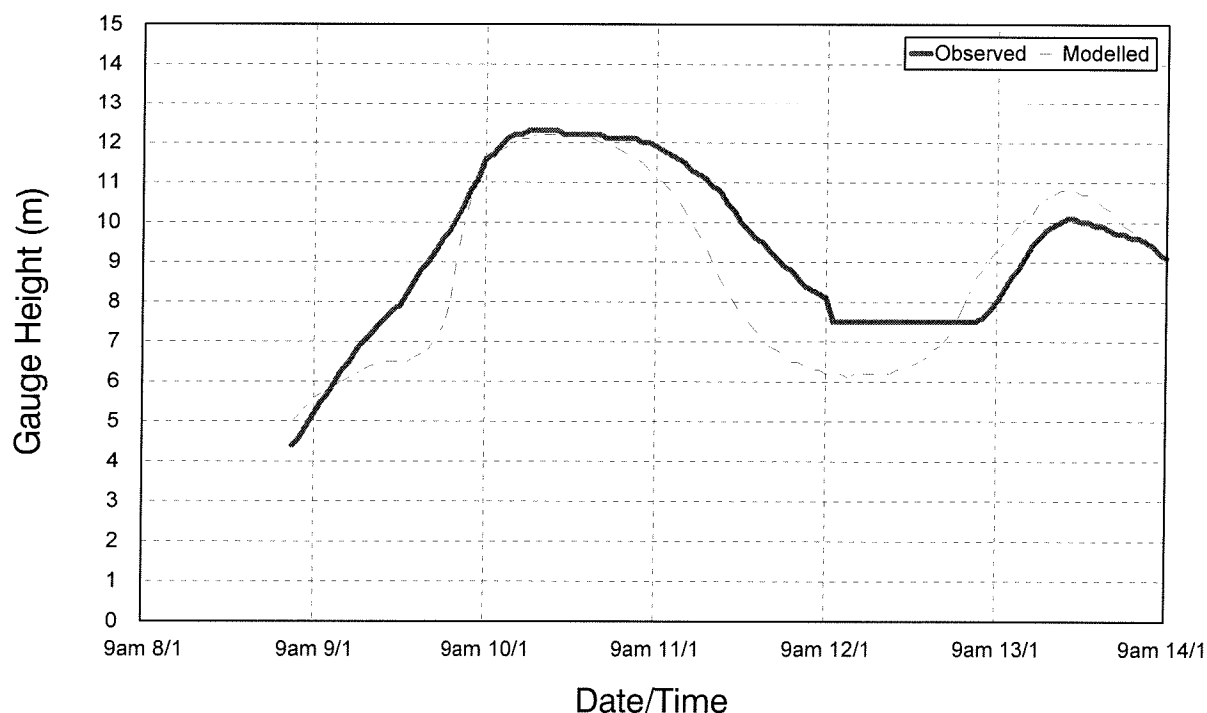
Figure 5.3 URBS Model - Herbert River at Gairloch

The URBS model works by dividing the catchment up into many small areas. The depth of rainfall and the volume of runoff from each subarea is estimated. Runoff from each subarea is routed through the catchment and the forecast height hydrographs plotted and compared with the observed height at each river height station in the system

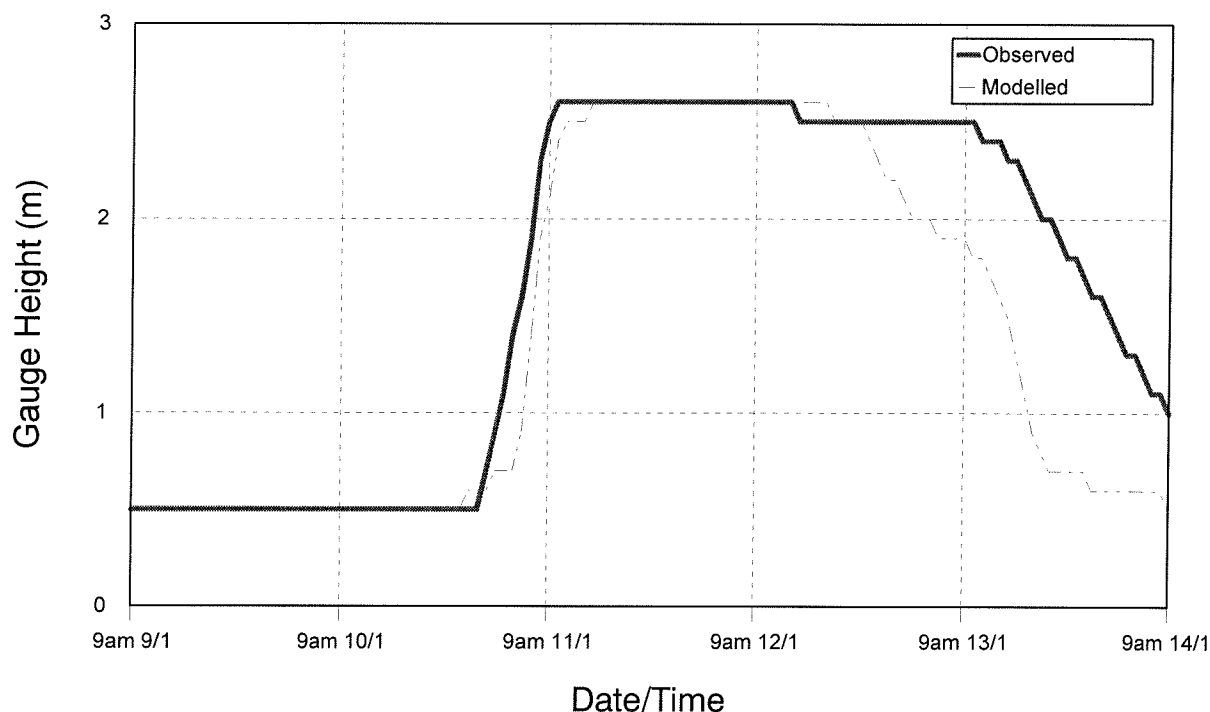
Figure 5.4 URBS Model Results - Houghton River at Giru

The Houghton River URBS model, shown in figure 5.4, reproduced well the rising limb and peak flood level at Giru during the flood. Recommended model parameters were adopted with an initial loss of 70 mm and there was a very close fit to the observed rising limb. The predicted peak flood level was 2.5 m, 0.2m below the actual peak. This peak
